The purpose of the PA is to assess the potential for releases of hazardous substances to have occurred at the CSC site and for the releases, if they have occurred, to have migrated to the Willamette River sediments and caused a threat to human health or the environment. Based on the October 1, 1999 DEQ Site Strategy Recommendation for the CSC site, the contaminants of interest (COIs) in the Willamette River sediments adjacent to the CSC site are:

CURRENT SITE CONDITIONS AND OPERATIONS

APPENDIX A

**PHOTOGRAPHS OF CURRENT SITE
CONDITIONS**

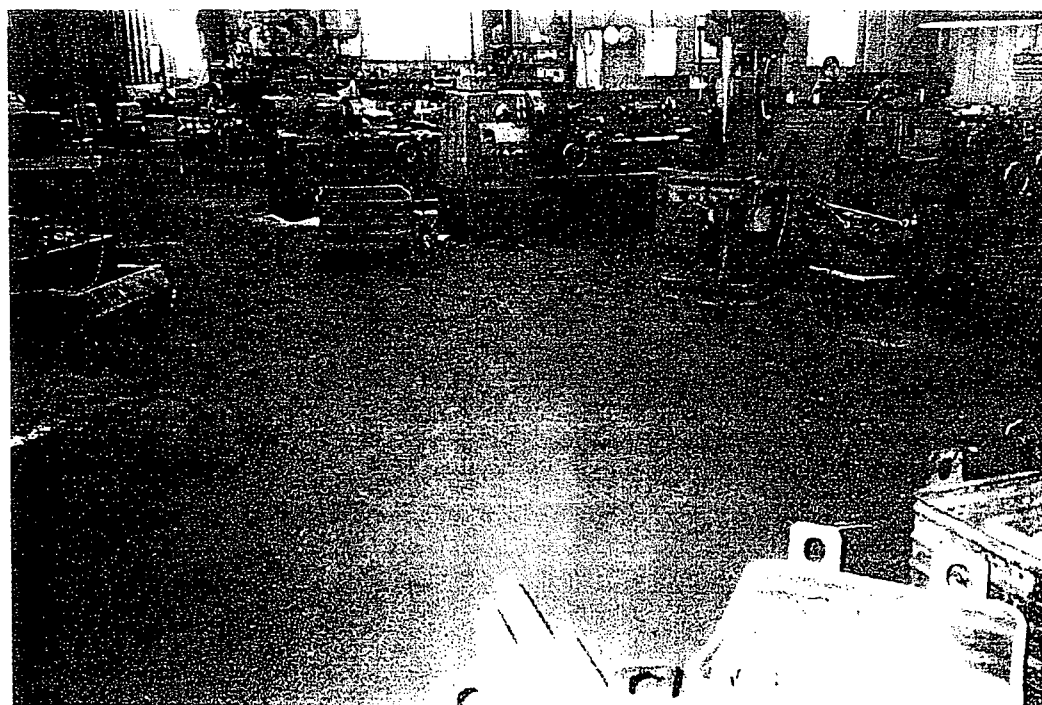
Photo No: 10

Machine Shop in north portion of Columbia Forge Building 1.

The northern portion of Building 1 is used for machining and contains several large lathes. This area has a sound concrete floor with no floor drains. Water-based cutting oils were observed in this area and the CSC representatives noted that the facility had been using water-based oil since the late 1970s. Prior to that time, petroleum-based cutting oils were used. No evidence of releases was observed in the machining room.

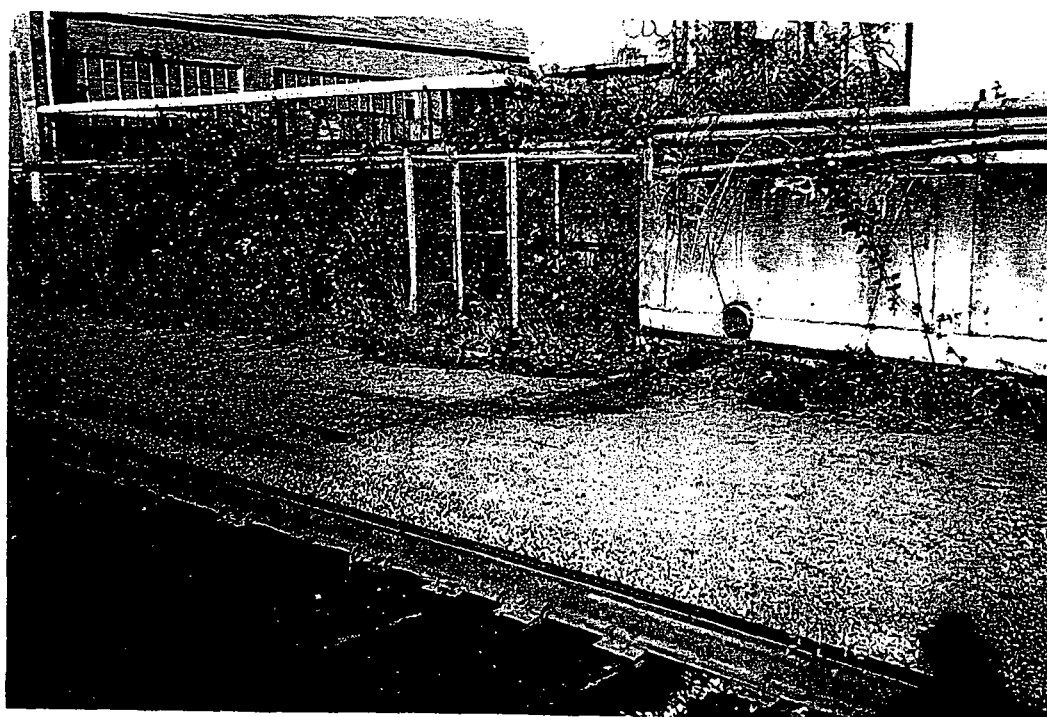
Photo No: 15

Looking north at drain line outlet from east end of Columbia Forge yard.

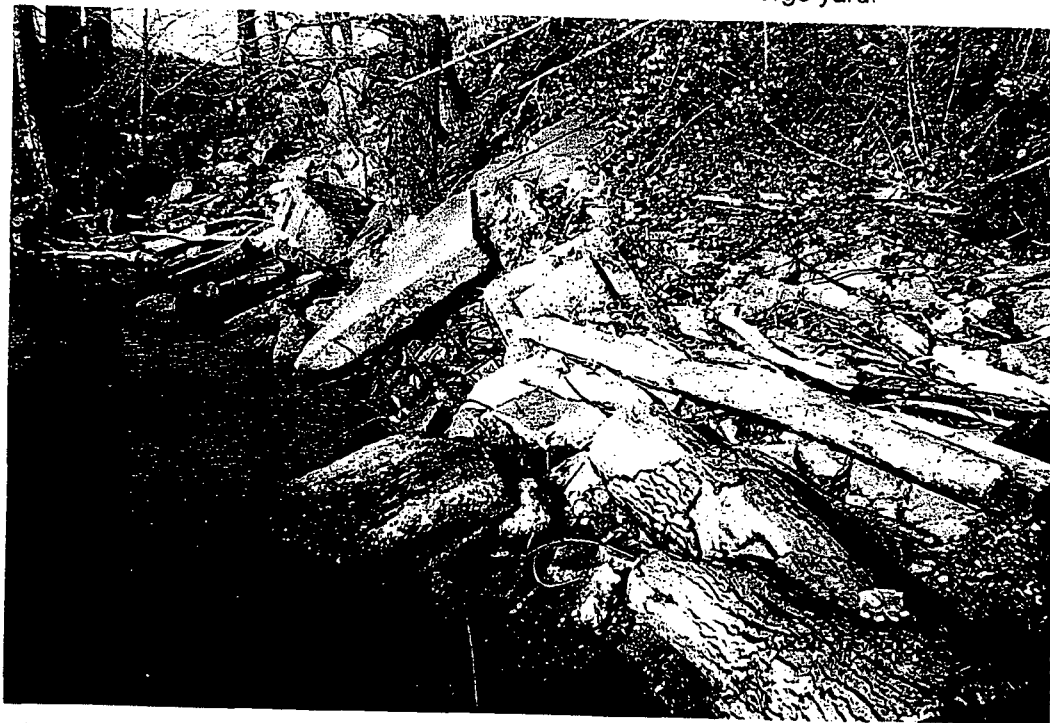
Photo No: 17

Typical river bank conditions.

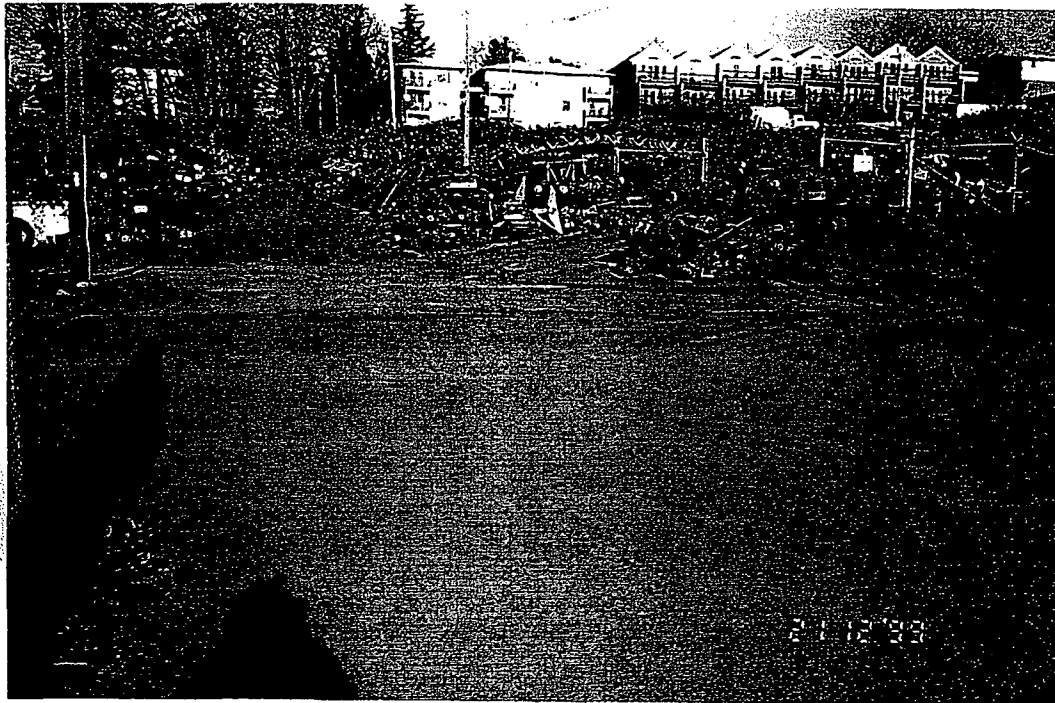
Photo No. 18

Looking north from north side of Columbia Forge/Lampros Steel yard at St. Johns Truck and Equipment debris yard. Storm water runs from this area, across Crawford Street, and on to and across the storage yard.

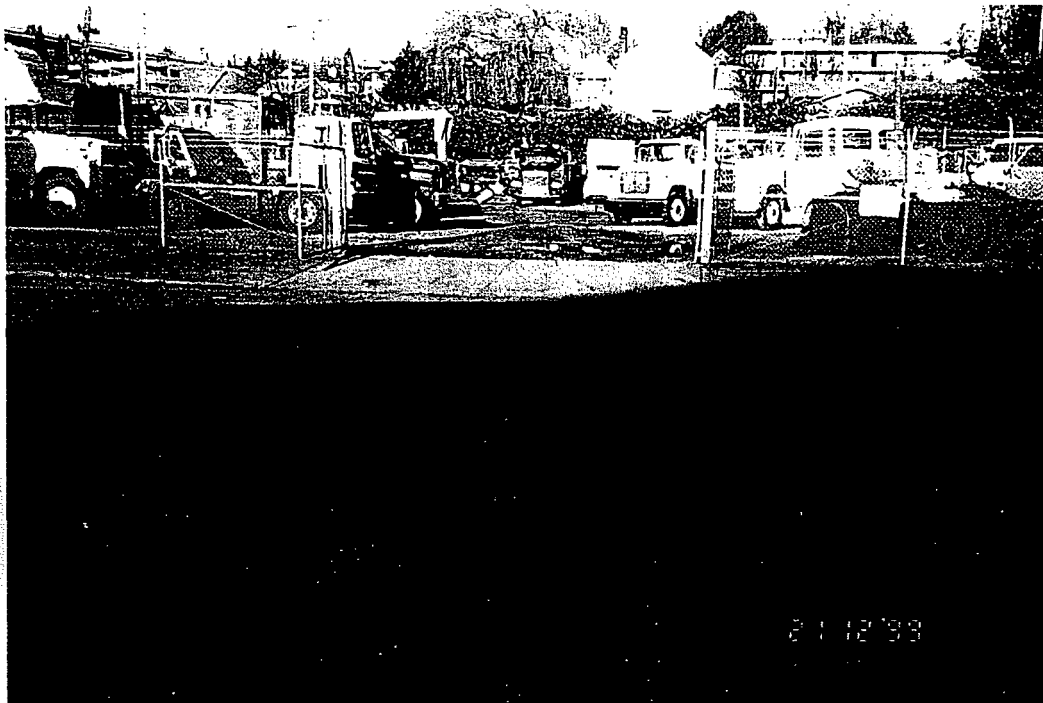
Photo No. 20

Looking north at St. Johns Truck and Equipment truck storage yard. Storm water runs from this area, across Crawford Street, and on to and across the Lampros and TLS Steel areas.

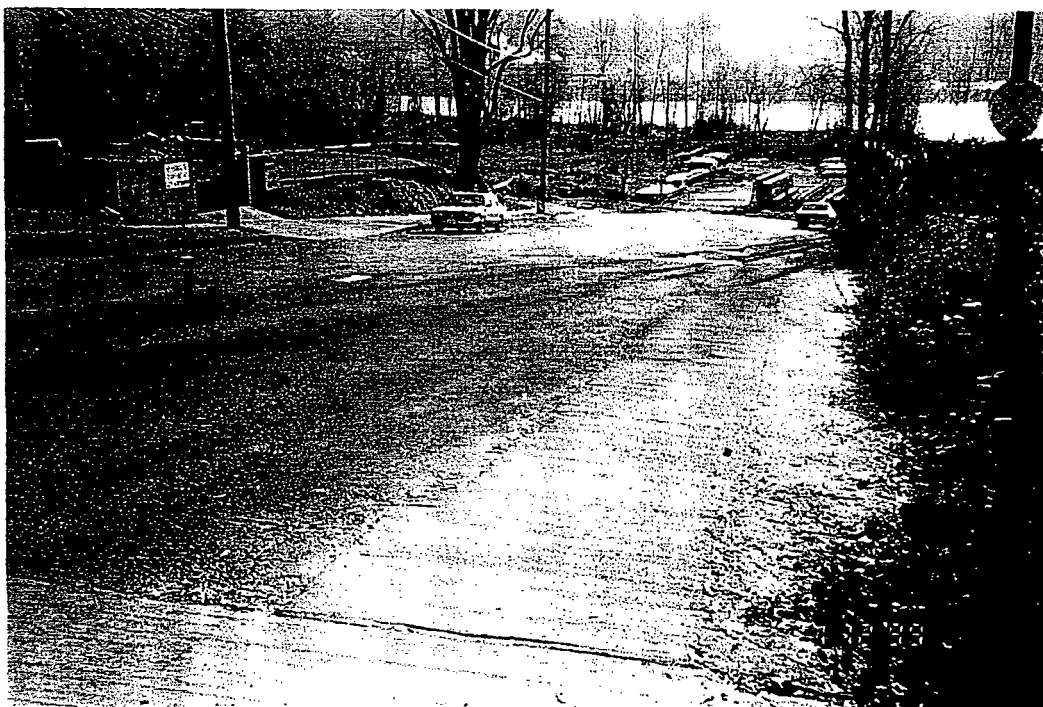
Photo No: 21

Looking south down North Richmond Street. Storm water flows down this street to UPRR rail spur area and to the Lampros Steel south storage yard.

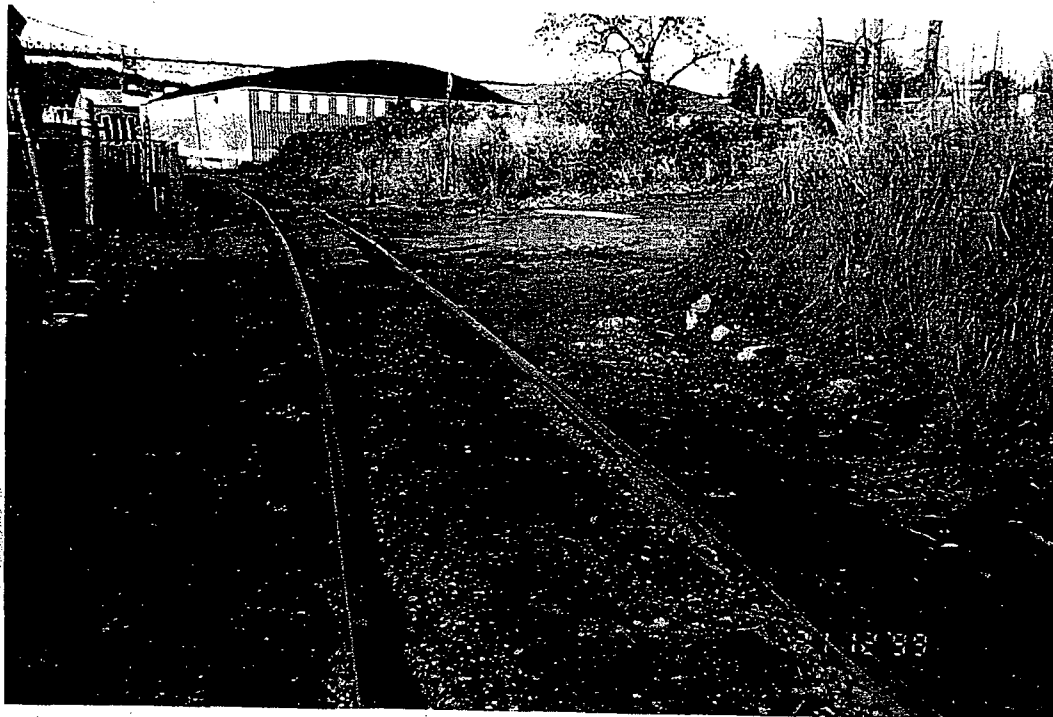
Photo No. 22

Looking west from east of site along UPRR rail spur. Note fresh oil stain in rail alignment east of Crawford Street. Stain drips continue onto the Crawford Street site.

Soil staining typical of rail road operations was observed along the UPRR rail spur separating the North and South Areas. The staining was consistent with petroleum hydrocarbons releases from diesel locomotives and spillage of products from the rail road cars.

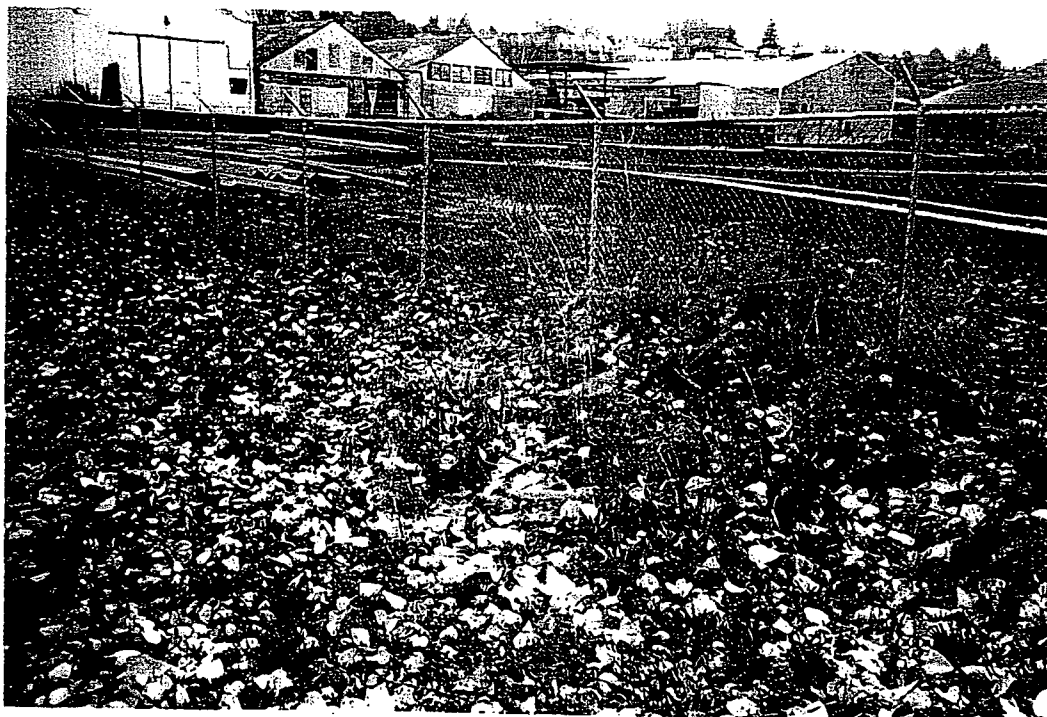
Photo No: 23

Looking northeast from City of Portland property west of Crawford Street site. Note asphalt and concrete debris pile on City property.

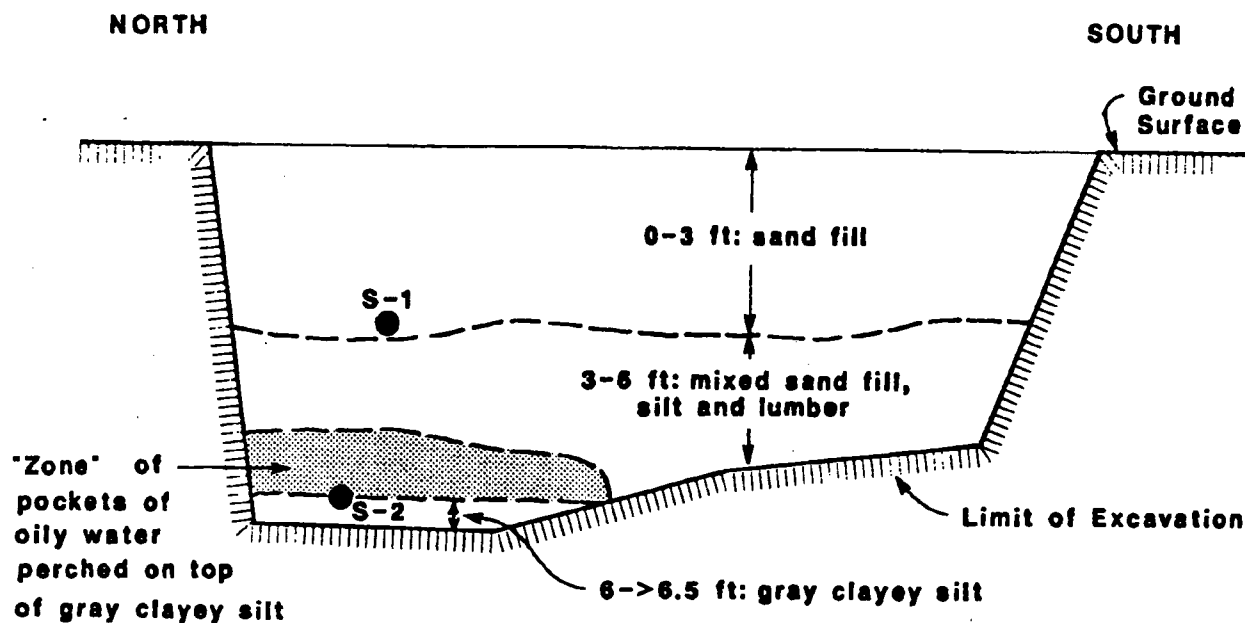
Figure 5

MMI (Lampros Steel Site)	
Cross Section, Test Pit 7, Sand-Fill Area	
Sweet-Edwards / EMCON, Inc.	
DRAWN BY <u>if</u>	INITIALS <u>if</u> DATE <u>2/2/98</u>
CHECKED BY <u>if</u>	
REVISED

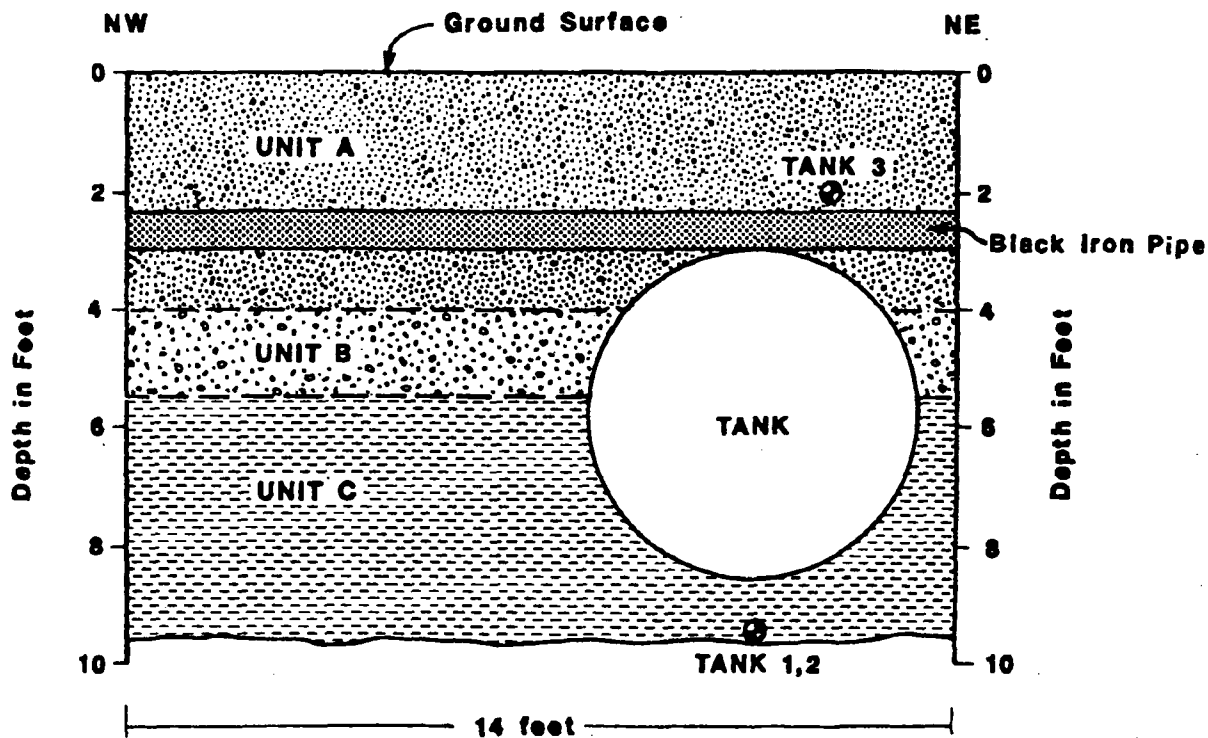
Figure 6

MMI (Lampros Steel Site)	
Tank Excavation Cross Section	
Sweet-Edwards / EMCON, Inc.	
DRAWN BY <u>js</u>	INITIALS <u>js</u> DATE <u>3/1/83</u>
CHECKED BY <u>js</u>	
REVISED <u> </u>
